Office Products Division  
Customer Engineering

**VIDEO SUPPLEMENT**

**8/9xx**

**Print Quality**

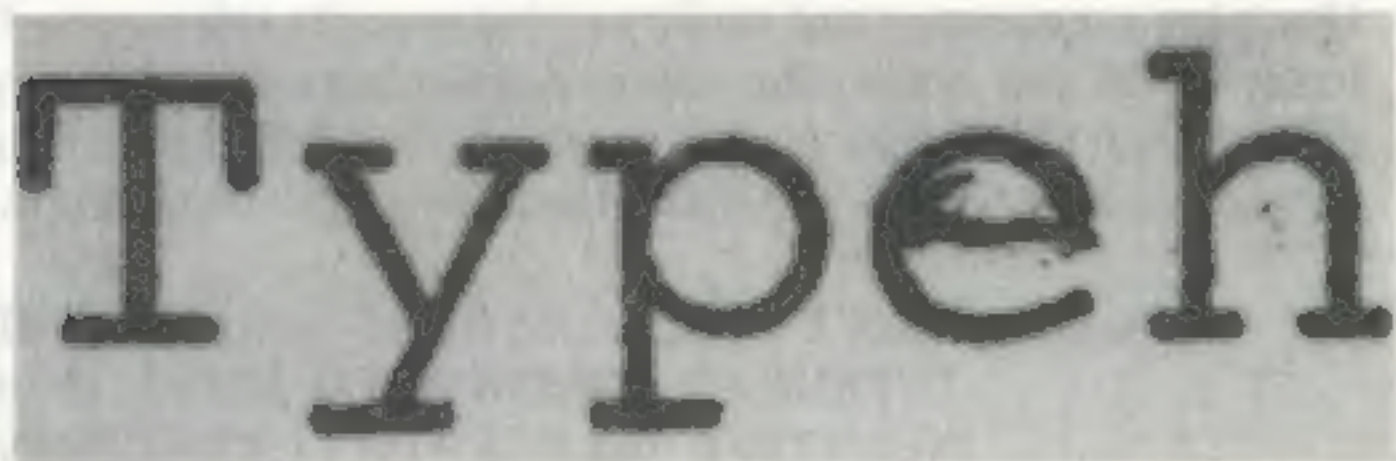
## CENTERFIL

This is when a character with a closed area either fills partially or completely with ink. The usual causes are faulty ribbon, ribbon being used not suitable for application, or dirty typehead.

Solutions to this problem are:

- Clean or replace typehead
- Check quality of ribbon and "use prior to date"
- Check powered and free flight
- Rotate and tilt detent — minimum play no binds.

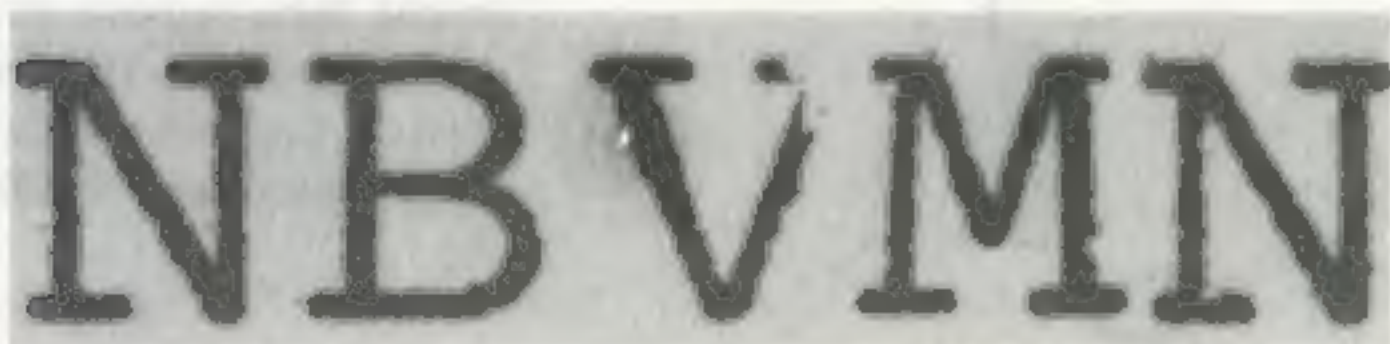
## COVERAGE

The usual reason for poor coverage is that the impression is too low or something has contacted the ribbon surface, removing the ink from the tape. Increasing the impression above a certain level will not improve coverage.

Other causes for poor coverage are:

- Poor ribbon quality
- Incorrect stick shift position
- Incorrect multi copy control lever position
- Cycle clutch adjustment
- Powered and free flight adjustments
- Print cam follower stop screw (APM frame 195)
- Drive belt tension

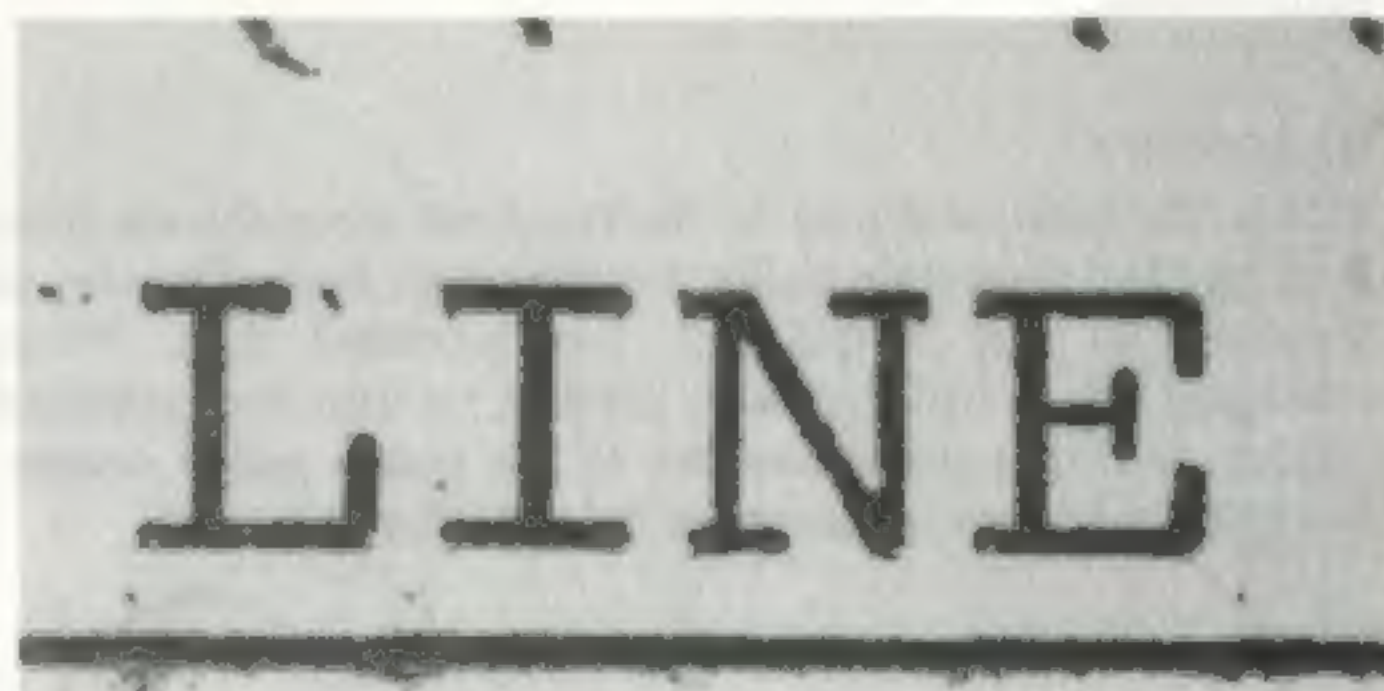
## SMEARING & SPLASHING

This is the uncontrolled extra ink transfer in any direction on the paper.

Reason for smearing is that just after printing the element, ribbon and paper stay in contact but the element and ribbon move together on the paper.

The probable causes are:

- Print shaft timing
- Escapement timing
- Weak bias spring in tilt ring (see CEM 292)
- Platen adjustments
- Yoke adjustments
- Excessive play in the stud mounting, the detent cam follower can cause smear because the detent timing changes.
- Detent cam follower adjustment (see CEM 292)
- Powered and free flight
- Print cam follower stop screw (APM frame 195)
- Check separator wire adjustment

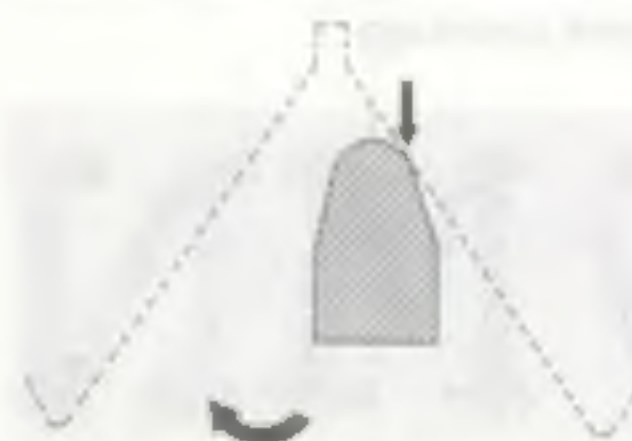
Figure 1

The notch to detent position should be as shown in figure 1. This condition must be correctly adjusted before continuing the check.

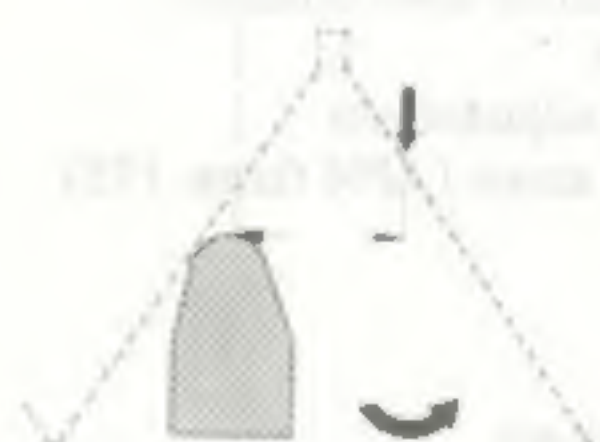
Figure 2

Withdraw the rotate detent then remove the typehead play in the positive (counter-clockwise) direction (APM 66)

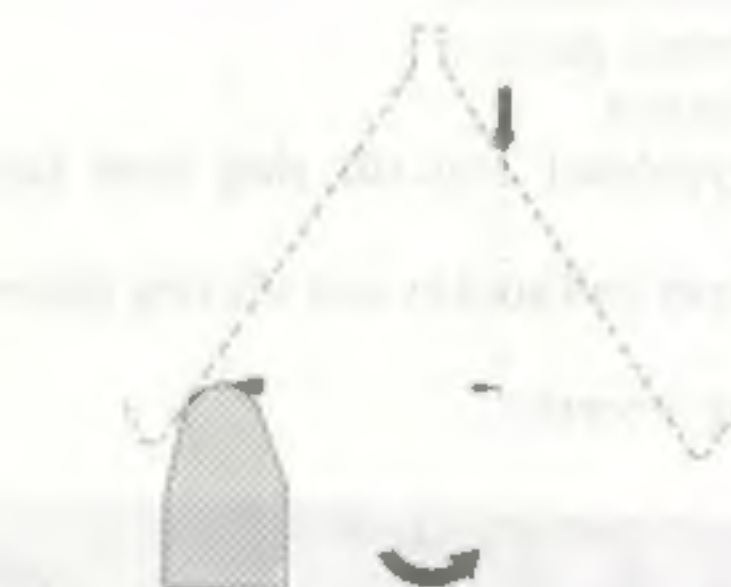
Figure 3

Remove play in clockwise direction. This position of the detent on the slope indicates the minimum headplay allowed.

Too much headplay is indicated when the detent is further down the notch than as shown in figure 3

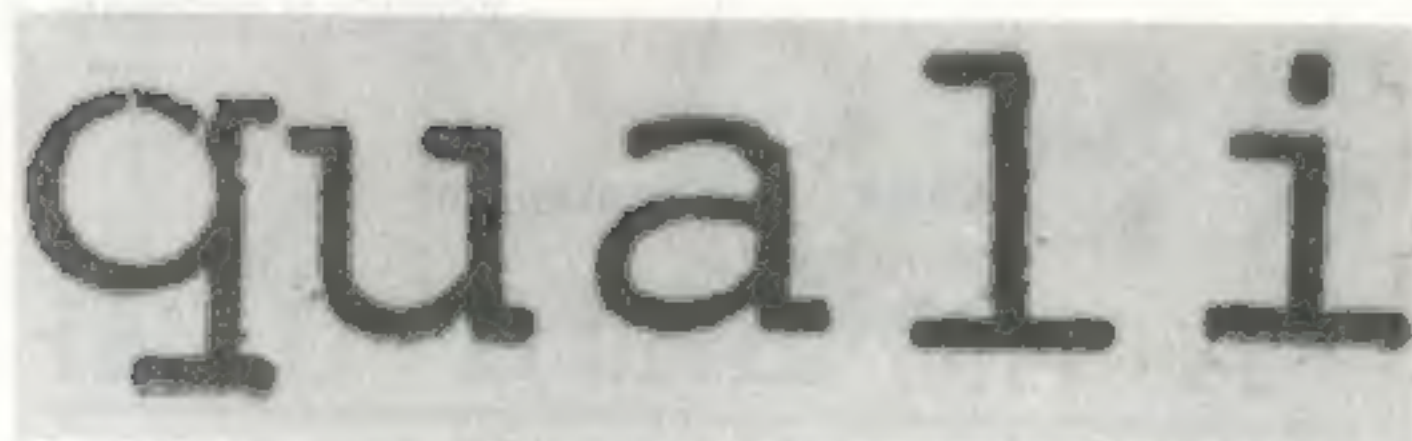
This area must be clean and lubricated. Check this area for dirt or chrome from the typehead. If chrome is found check the typehead and replace if necessary.

Print Sample With Dirt (Vertical Misalignment)

If chrome is found check the typehead and replace if necessary.

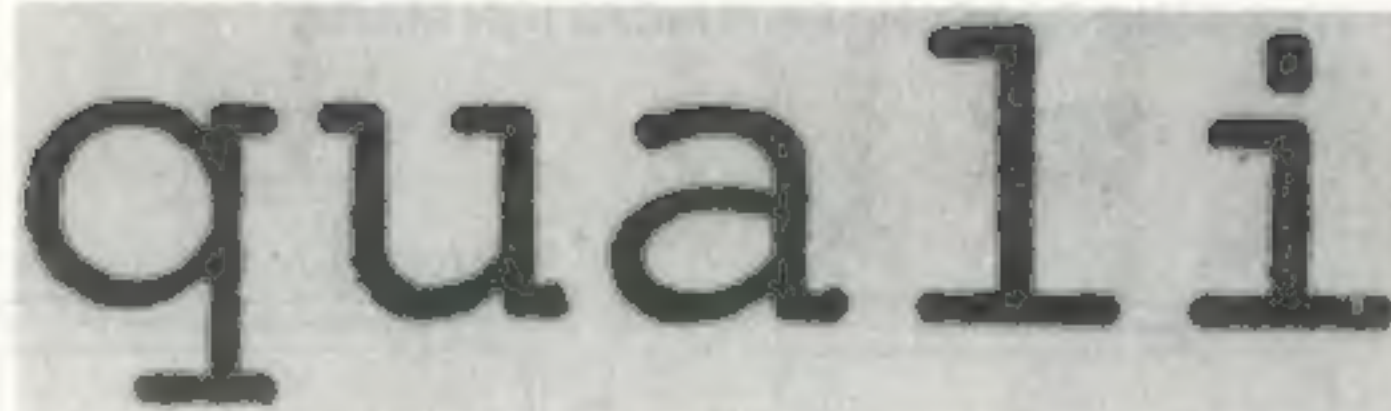
Print Sample After Removing Dirt

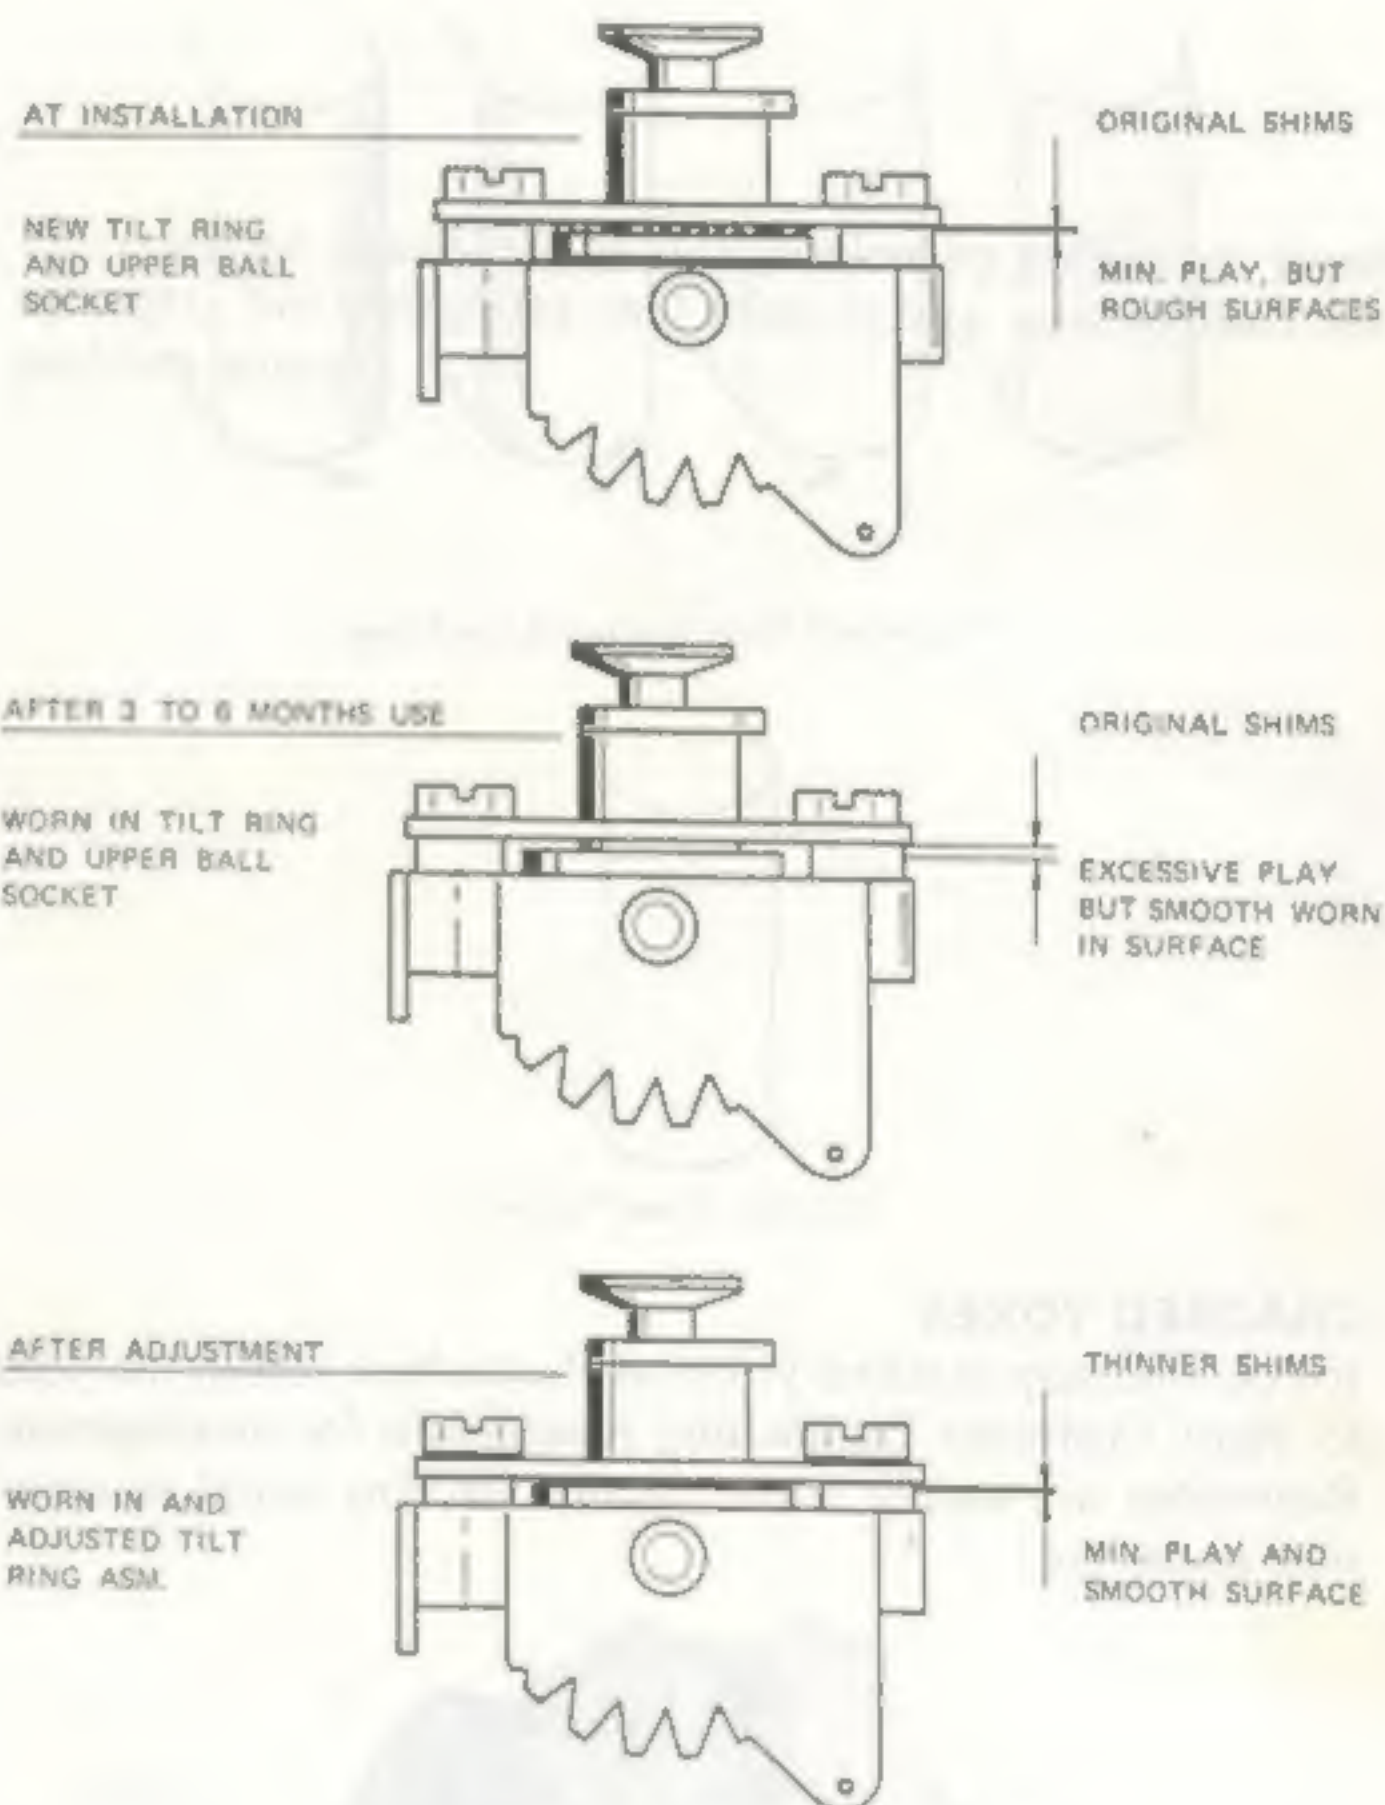
## UPPER BALL SOCKET AND TILT RING

A new tilt ring assembly takes some time to "wear in". For this reason if excessive upper ball socket play is found the tilt ring should be reshimmed and not replaced. Replacing the assembly only cures the problem for a short time until wear once again takes place (see diagram).

To ensure that you do not create a bind after reshimming. Perform the following:

Half cycle a negative 5 character note where the rotate detent touches the slope of the notch at entry.

After reshimming — half cycle a negative 5 character again, the rotate detent should touch the slope of the notch at the same point as before. If not a bind has been created and the upper ball socket needs shiming again.

Do not increase the rotate spring tension to overcome binds.

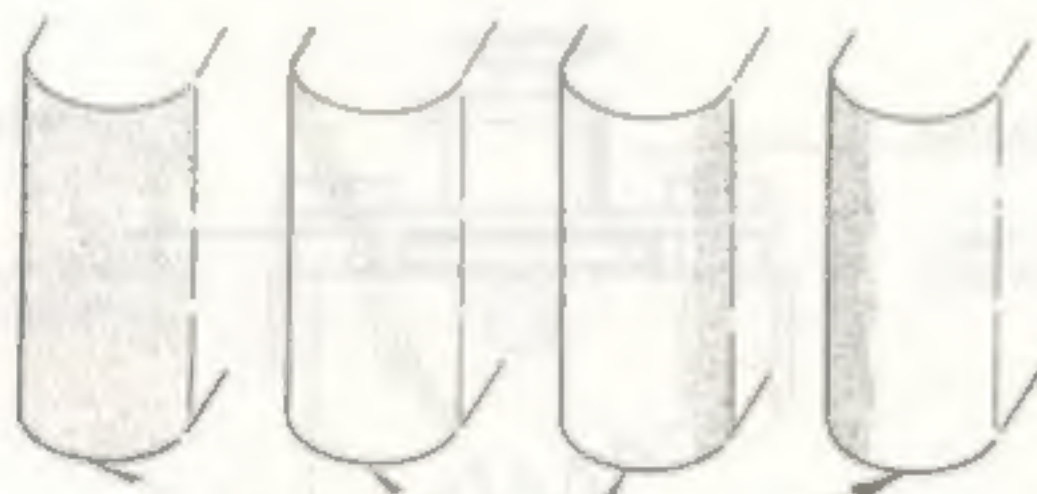
If the chrome surface of the typehead is found to be worn on the inside check the tilt ring nose for a wear pattern caused by the rough surface of the typehead.

Incorrect Wear Patterns On Nose

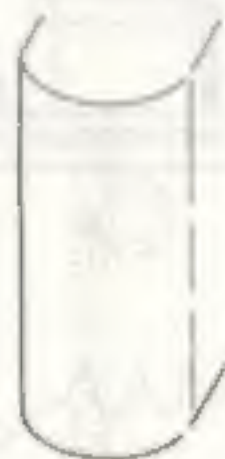
Correct Wear Pattern

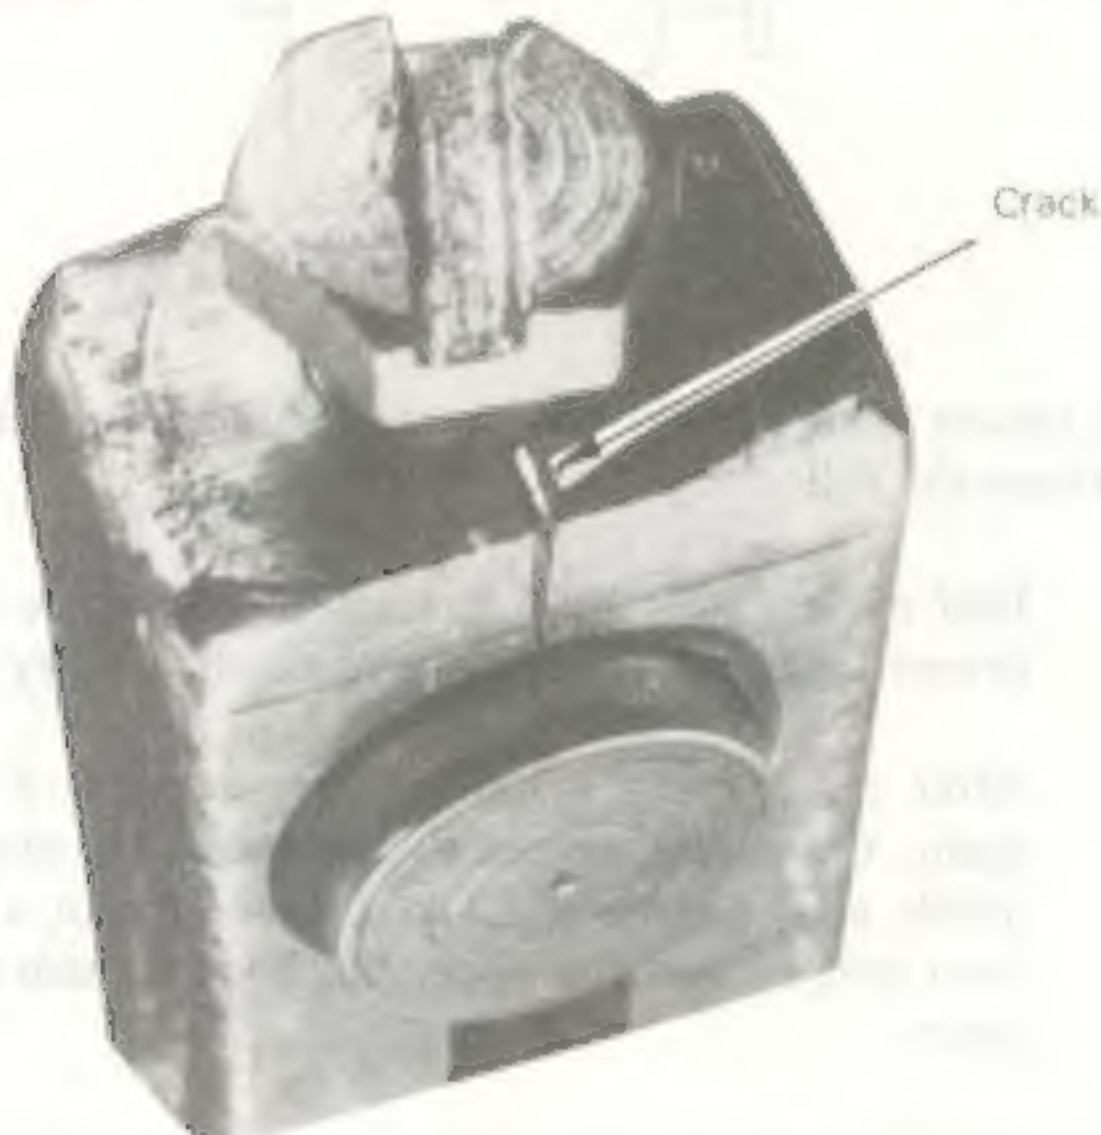
## CRACKED YOKES

If you find any cracked yokes as shown here return the yoke to Plant Customer Engineering Amsterdam for investigation. Remember to supply some details Machine serial number, time in use etc.

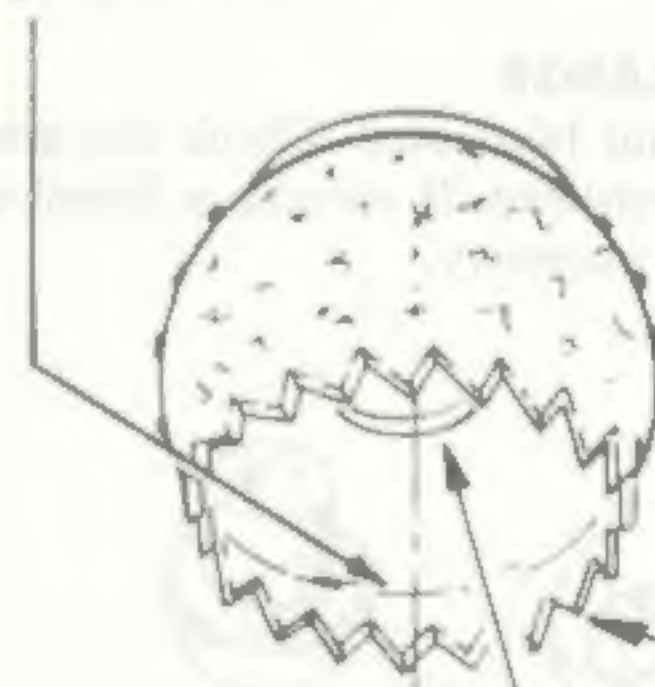
## TYPEHEAD

Check for wear on inside surface  
— Replace if worn—

Check for broken or worn teeth.  
— Replace if necessary —

Check for broken or worn insert  
— Replace if necessary —

**CLEAN, INSPECT AND LUBRICATE THE TYPEHEAD**  
during each customer visit.

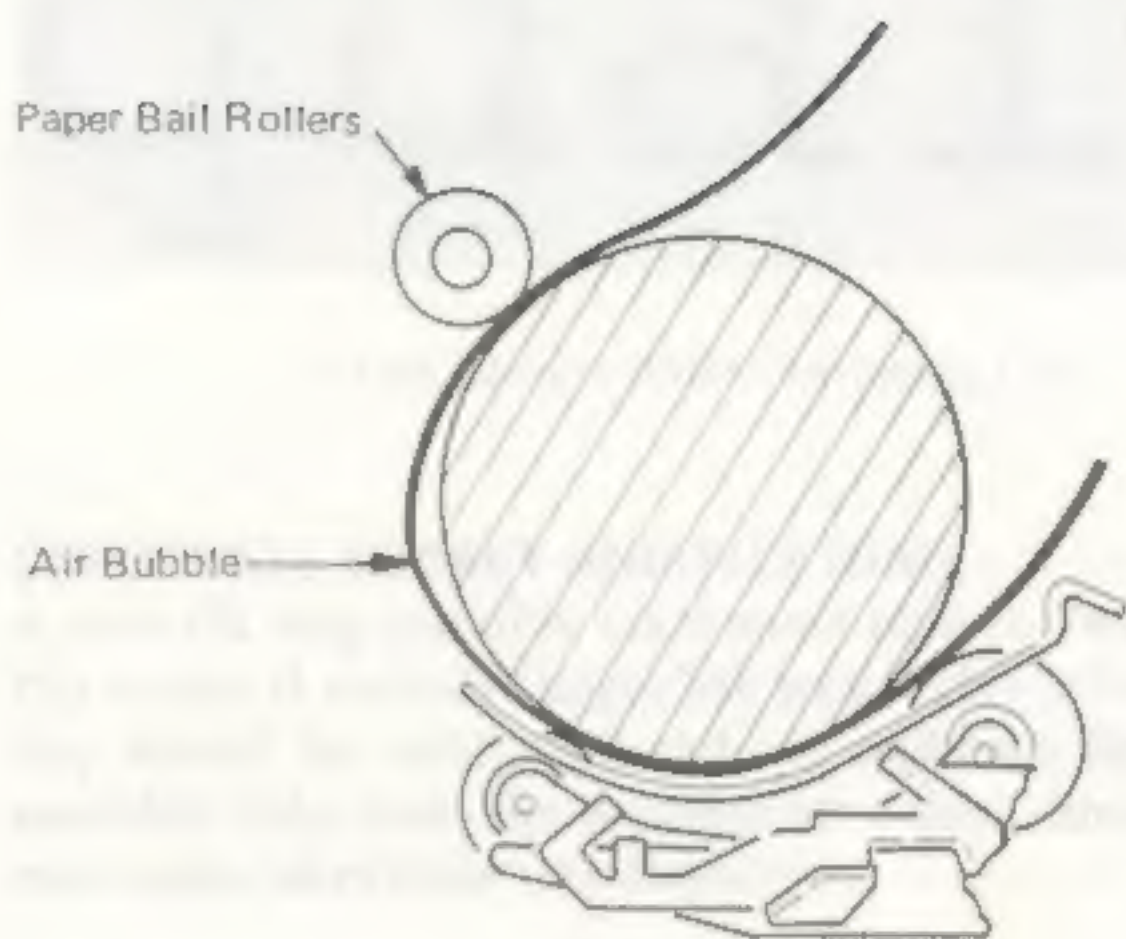
The print sample below was caused because the paperbail rollers were dirty inside. The rollers should be removed and cleaned inside and if necessary replaced.

The operator usually solves this problem by pulling the paper up tight, but complains that after typing several lines the problem returns.
